## RESIDENTIAL HOME INSPECTION

1234 Main Street  
Vancouver, WA 98683

Buyer Name  
09/30/2024 9:00AM

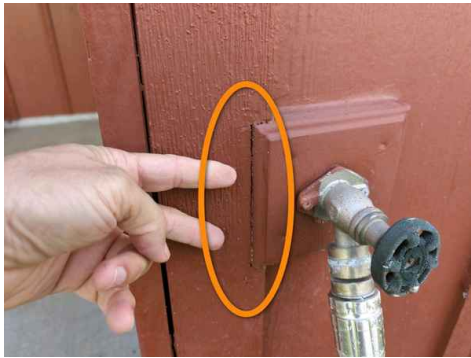
Left side hose bib

#### **SEALANT MISSING OR GAPPING**

**Issue:** There is missing or gapping sealant that can allow water entry and potential damage to the structure.

**Remedy:** Have high quality sealant applied or repaired in areas as necessary to prevent water entry.

**Recommended time frame:** Ideally, prior to significant rainfall

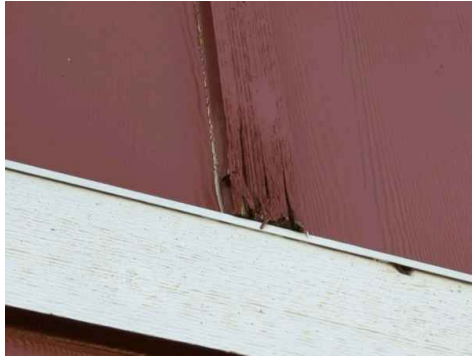
Right side trim

**WOOD DECAY**

**Issue:** Wood decay is present in siding or trim on the exterior of the building.

**Remedy:** Have any decayed areas replaced to prevent potential fungal growth, more extensive damage to the structure, and pest intrusion.

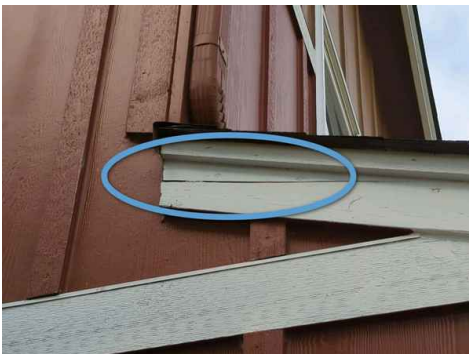
Left front corner

Paint / prep, Seal splits / cracks, Loose nails / panels

**Issue:** The siding needs general maintenance or minor repairs. Make siding repairs promptly to help prevent water intrusion.

**Remedy:** Have the siding repaired or maintenance performed to help prevent water damage to the structure.

- Repair or install sealant in gapping or missing sealant areas
- Repair any over driven nail holes by caulking / sealing
- Repair failing paint by removing loose paint, priming, and re-painting
- Repair or seal any gaps, splits, in the siding or joints as necessary
- Drive or replace any nails which are coming loose

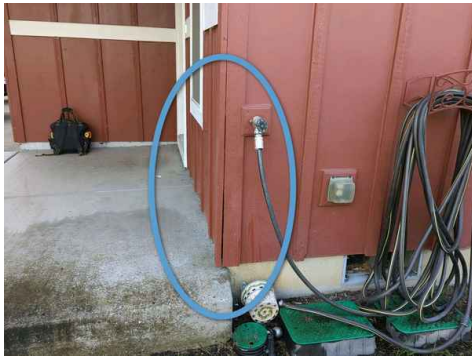
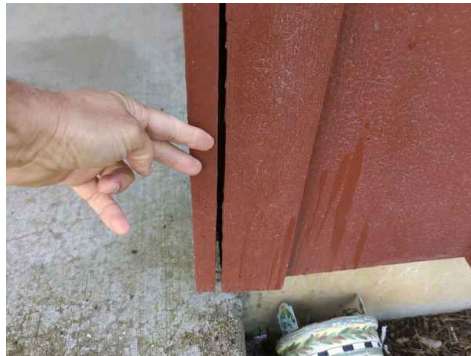
Right front corner

**LOOSE, MISSING, OR DAMAGED TRIM**

**Issue:** The trim is loose or missing in some areas and needs repair. Loose or missing trim could potentially allow water entry and damage to the structure.

Trim is loose

**Remedy:** Repair by a contractor or handyman

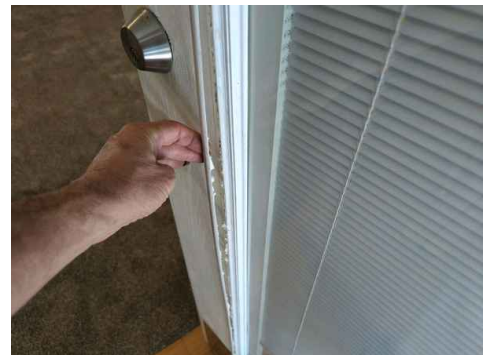
**TRIM PIECE LOOSE ON DOOR**

The rear door facing Rasmussen Street has loose vinyl trim around the window. Repair as necessary or replace.

Loose trim, damaged

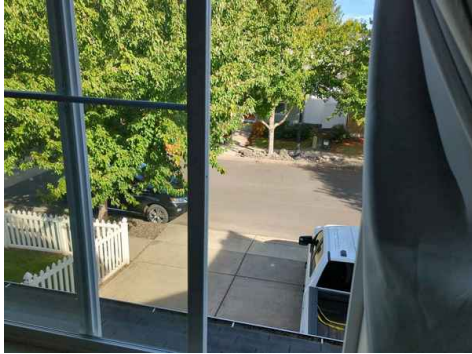
2nd Floor bonus room

### MISSING OR DAMAGED SCREEN

**Issue:** There are missing or damaged screens for some windows. Screens in good working condition are important to help prevent pests and insects from entering the home. Pests and insects can potentially cause health related issues.

**Remedy:** Have screens repaired or installed as necessary.

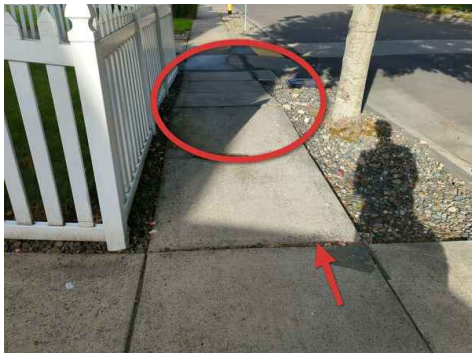
**Issue:** Some areas of the walkways are uneven and are a potential trip hazard. Vertical offsets in walkways of approximately 3/8" or greater are noted as trip hazards.

Front public walk away, tree roots have damaged sidewalk

**Remedy:** Have a contractor repair the walkway. Repair is often accomplished by grinding off the concrete to smooth out the surface.

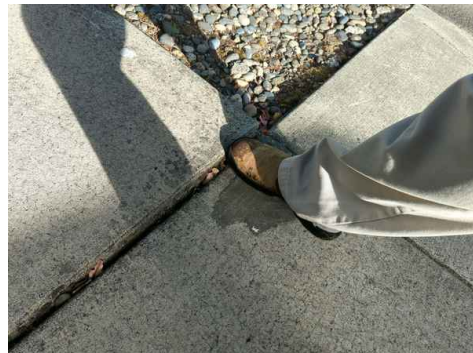
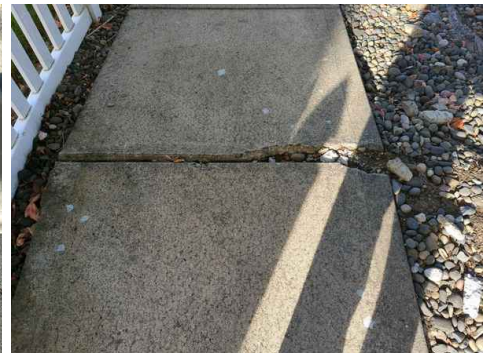
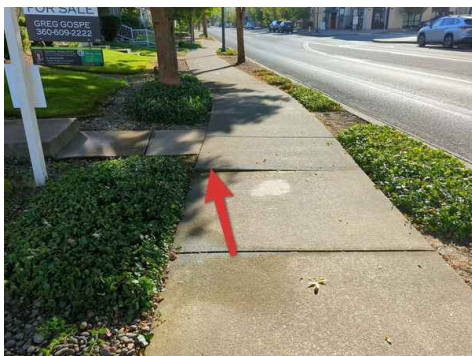
Rear public sidewalk offset

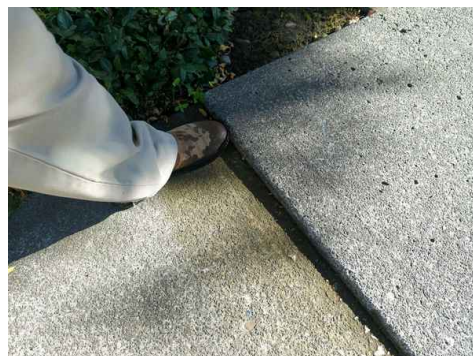
Offset is a trip hazard

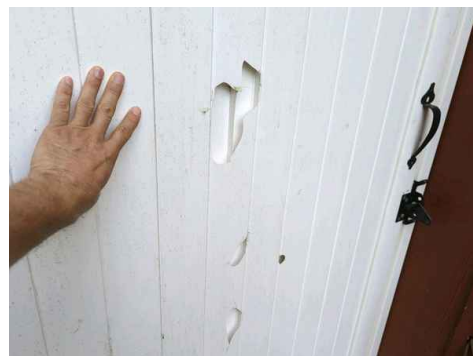
**FENCING NEEDS REPAIR**

DAMAGED TO LEFT SIDE GATE

While beyond the scope of the home inspection, I like to point out extra little items like fencing that needs repair. The fencing and gates need some repair on this home.

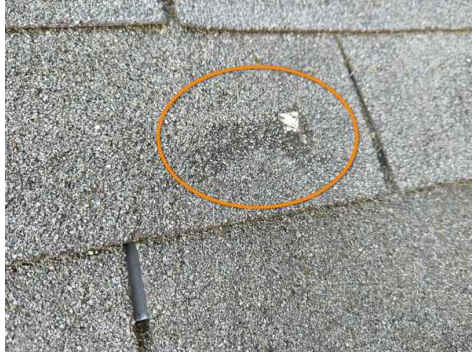
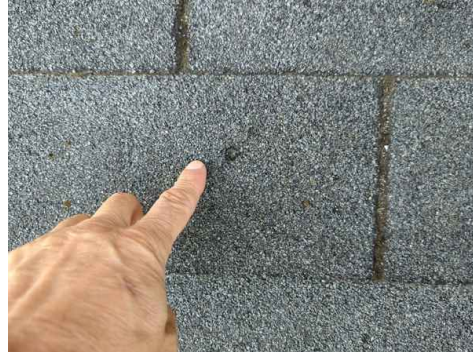
**Issue:** The roof covering needs repairs / maintenance to correct the mentioned items. It is important to make roof repairs in a timely manner to prevent leaking and protect the structure.

Damaged shingle

**Remedy:** Have repairs / maintenance performed by a roofing contractor to protect the structure from water intrusion

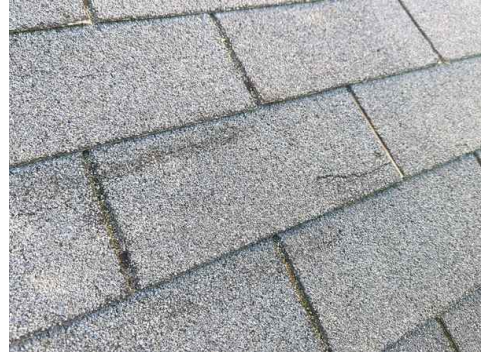
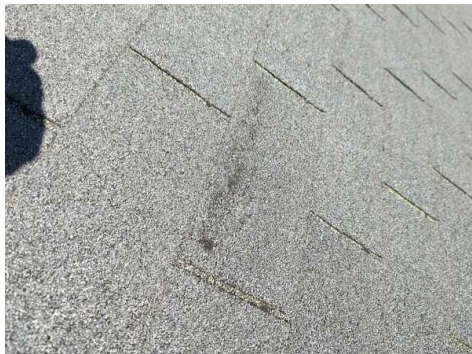
Horizontal cracking of shingles

Horizontal cracking and granule loss of shingles

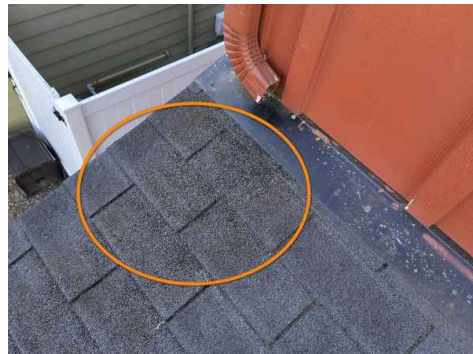
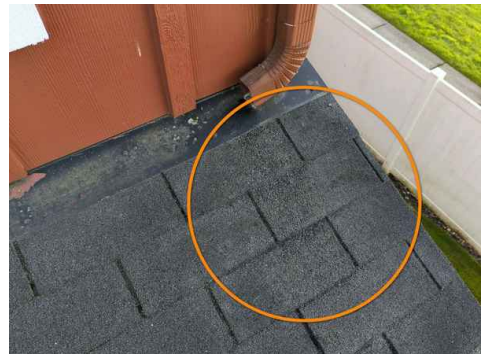
Heavy granule loose under downspout

Heavy granule loss under downspout

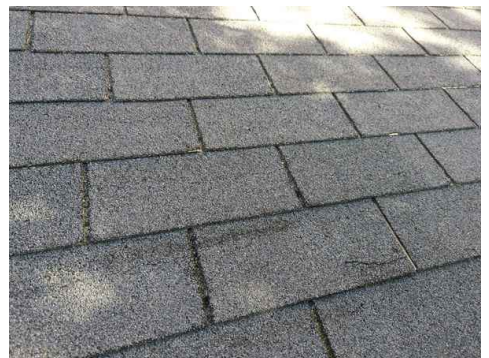
**Issue:** The roof covering appears to be at the end of its useful life given appearance, and should be reviewed by a roofer for further recommendations regarding time frame and cost for replacement.

**Remedy:** Have a roofer review the roof for recommended time frame for replacement.

**Recommended time frame:** During your contingency period

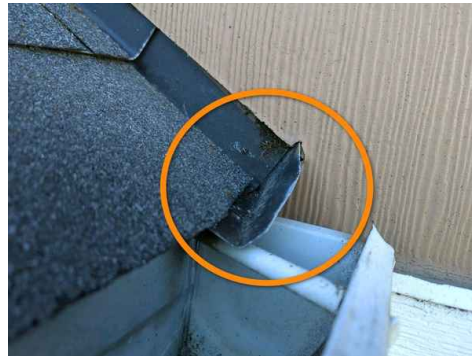
**Issue:** There is missing, damaged, or inadequate kickout (diverter) flashing at some roof / wall intersections. Kickout flashing directs water away from the side wall and into the gutter to prevent water running down and potentially behind the wall cladding causing damage to the structure. Kickout flashing should be a minimum 4x4 inches for proper water management. Older homes did not require it, but it is a very good item to have installed for water management because the roof / wall intersection is a problematic area for water intrusion.

Undersized and inadequate kick out flashings

**Remedy:** Have a roofing contractor add / repair a full sized (4x4 inches) kickout flashing properly integrated with step flashing and water resistive barrier to areas not having one or where inadequate / damaged.

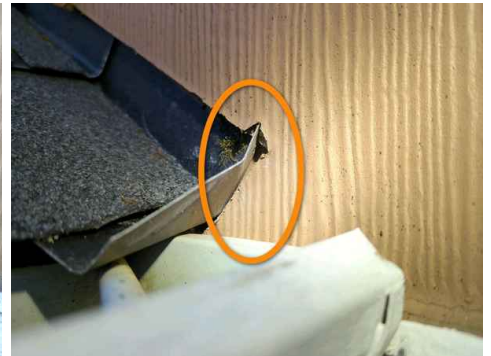
Kick out flashing is not properly sealed

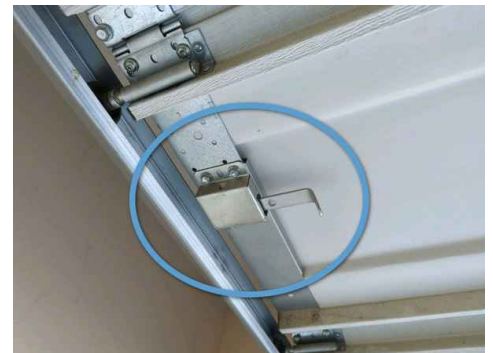
Manual lock installed on overhead door with opener

**Remedy:** Remove or disable the lock

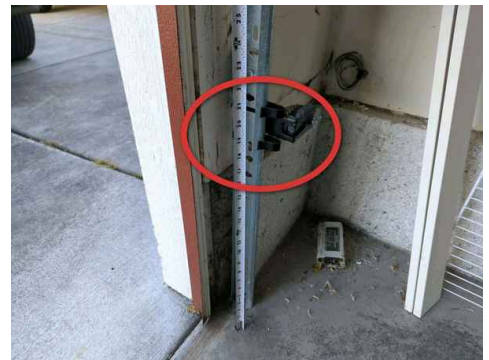
Photo sensors installed too high

**Recommended time frame:** Immediately if small children will be present

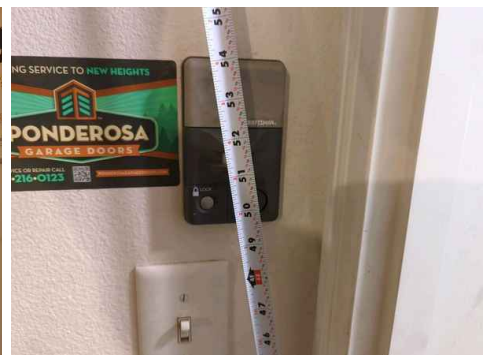
Hoping there is a little over 4 ft above the adjacent walking surface

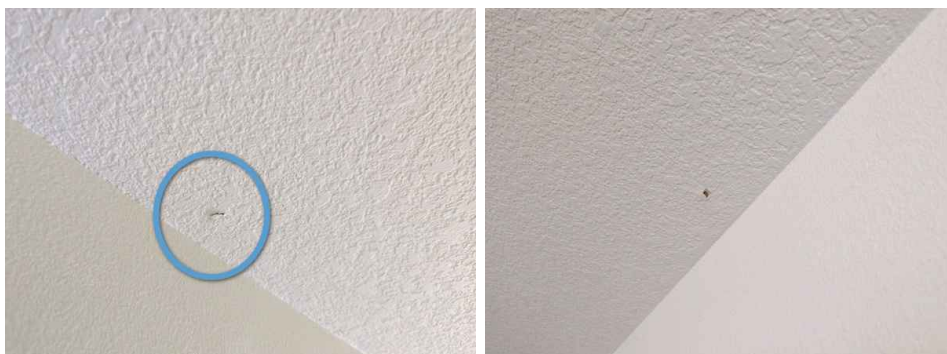
Example

There are a few 'nail pops' around the home where the nail heads have pushed the sheetrock / spackle out and has a bump on the ceiling. This is cosmetic in nature and normal to see in most houses at some point. Repair as necessary.

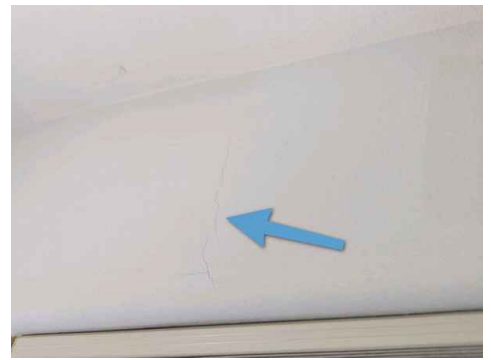
2nd Floor Bathroom

**NORMAL  
DRYWALL HAIRLINE CRACKING**

There were some typical hairline cracking in the drywall around the home. This appears cosmetic in nature and is likely due to minor settlement or improper joint preparation. Repair as necessary.

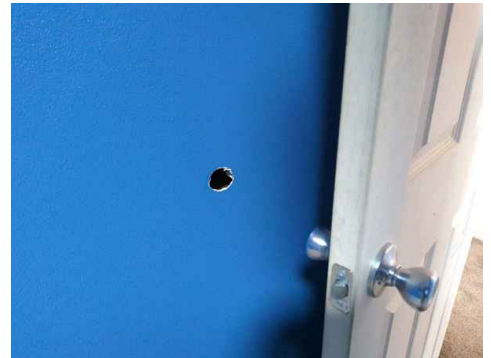
**Issue:** There is a hole in the wall that needs repair. Holes in interior walls are in general considered a cosmetic item, however, in places such as under sinks and cabinets holes in walls could allow pest entry and should be sealed.

**Remedy:** Repair as necessary

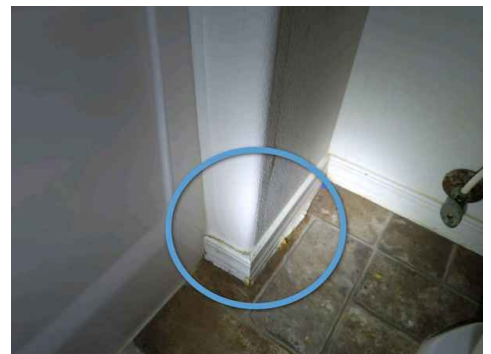
**MOISTURE  
DAMAGE BASEBOARD**

**Issue:** There is moisture damage to a baseboard.

**Remedy:** Have it repaired / replaced.

**Recommended time frame:** When feasible

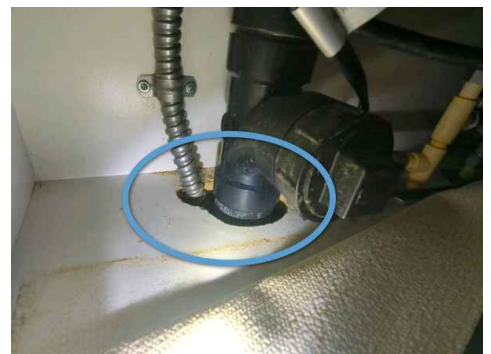
KITCHEN SINK

It's a good recommendation to seal any holes around plumbing pipes under sinks to prevent air movement in cavities, to prevent water potentially entering the gaps under the cabinet, and to help prevent pest entry.

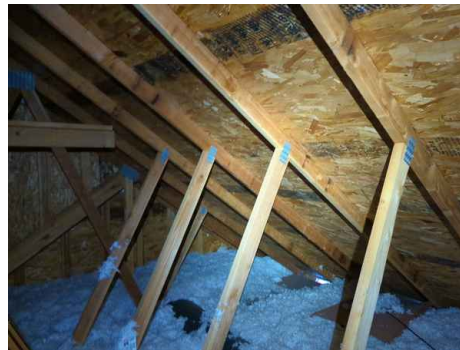
Engineered wood trusses, OSB sheathing

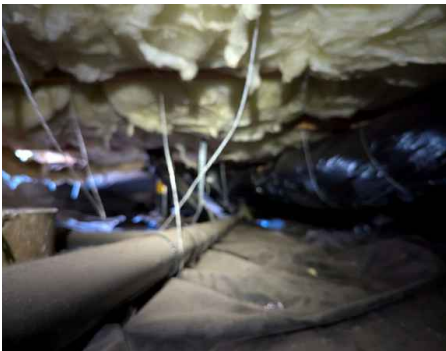
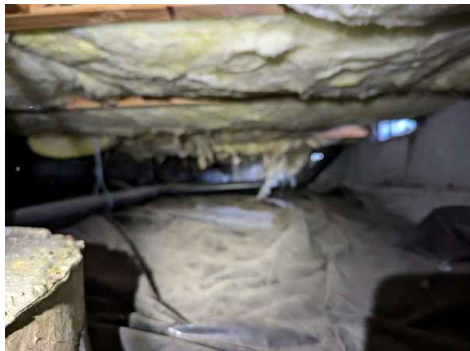
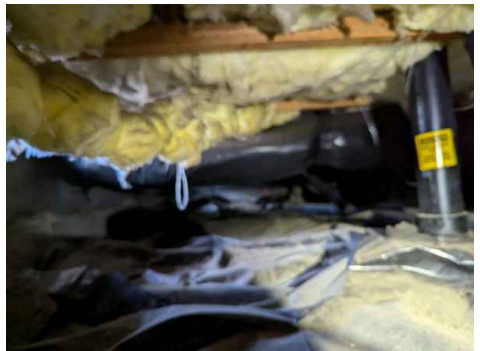
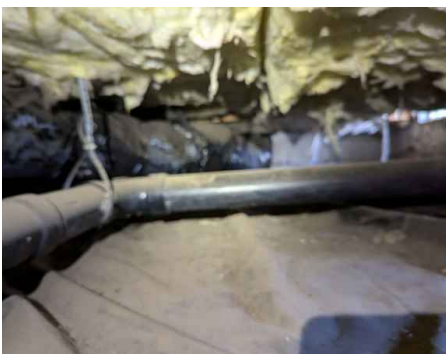
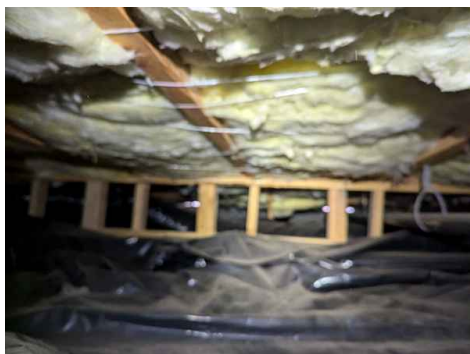
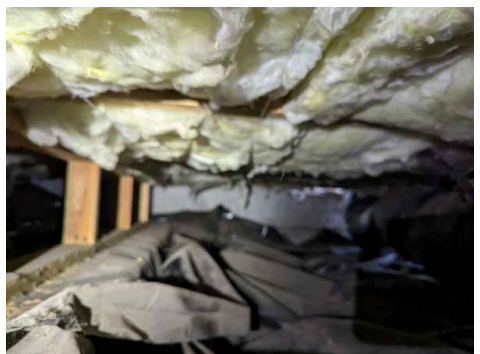
**Foundations, Basement and Crawlspace: Crawlspace #1 general photos**

Some overall general photos of the crawlspace.

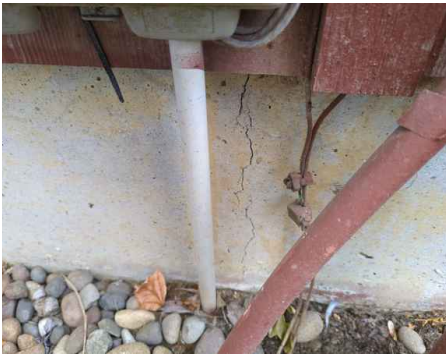
**Foundations, Basement and Crawlspace: Typical foundation shrinkage cracks**

There are some typical vertical cracks in the foundation wall. All concrete cracks, and these appear to be typical shrinkage cracks. No action is necessary.

Notes: cracks from hairline to 1/8 inch are generally considered negligible and do not indicate a structural issue. Ensure the downspouts are properly functioning and get water away from the foundation at least 5 feet.

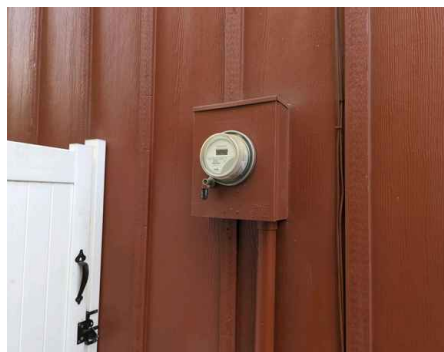
#### Service entrance location

Exterior of home, Left side

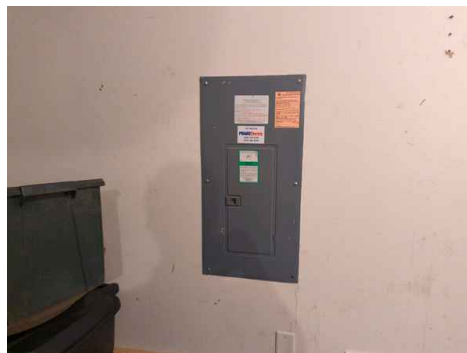
Working clearance around electrical panels

Maintain proper clearance around electrical panels which is 30 inches wide measured either from the centerline (15 inches each way) or from one edge of the panel, 3 feet to the front of the panel, and all the way from 6 feet 6 inches high to the floor. It is important to keep this area clear for working access and for quick access in the event of an emergency.

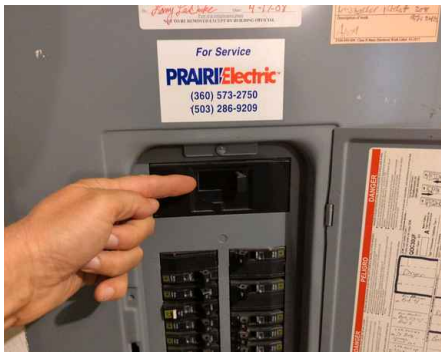
### Service Equipment / Electrical Panels: Panel Manufacturer

SQUARE D

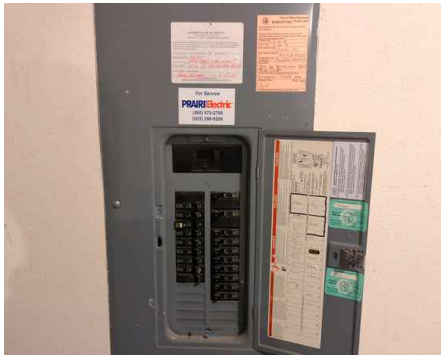
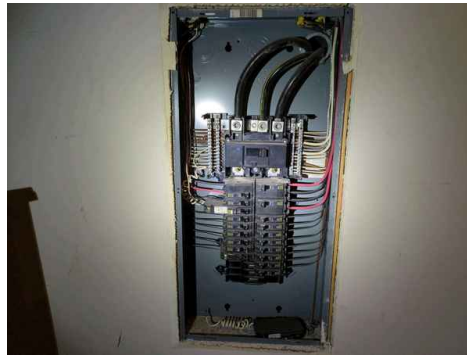
### Service Equipment / Electrical Panels: Main panel inspected

The main electrical panel was inspected.

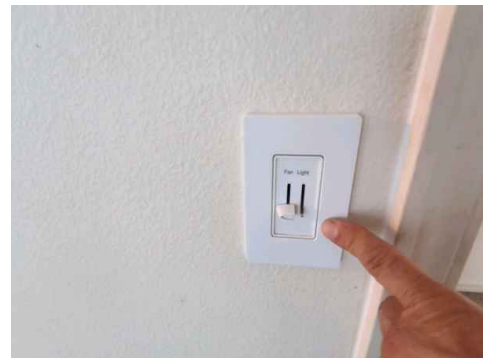
**MISSING KNOB ON FAN SWITCH**

The fan switch at the master bedroom needs to have a knob installed on the metal rheostat control.

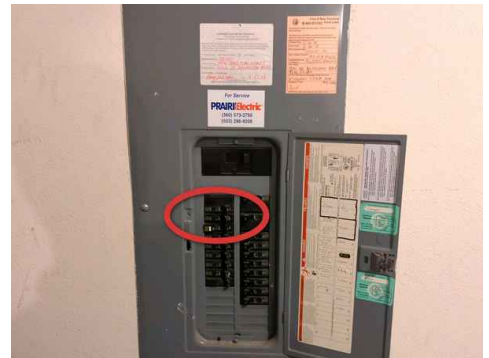
In new construction current standards require afci on all 15 and 20 amp breakers for conditioned areas of the home. There is an area with a 15 or 20 amp branch circuit that does not have AFCI protection as required. Have this repaired by an electrician as it is a current safety requirement.

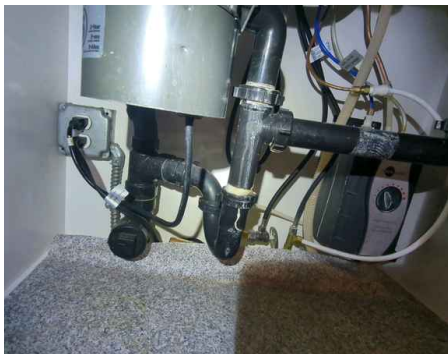
### Drain, Waste and Vent: Past leaking evident

Staining on multiple drain line areas under the kitchen sink

There are some staining or signs of past leaking at a drain pipe. I did not notice any current leaking. Monitor for any future occurrences.

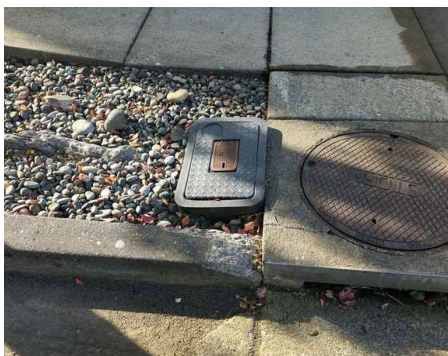
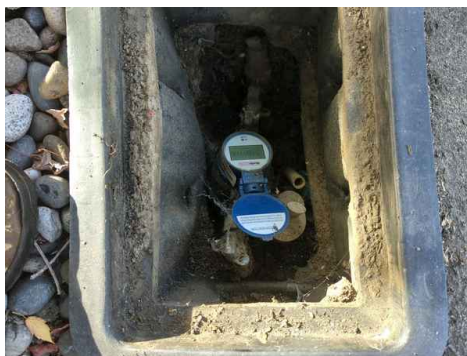
### Water Supply, Distribution and Fixtures: Water Meter Location (if public)

front of home by street

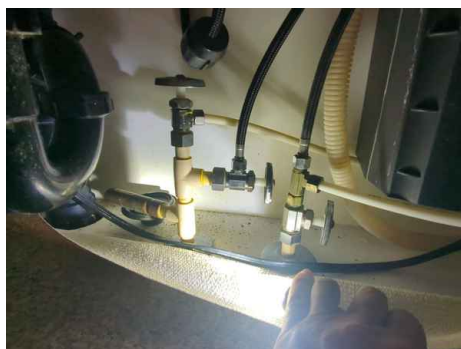
**Water Supply, Distribution and Fixtures: Water distribution piping material**

CPVC

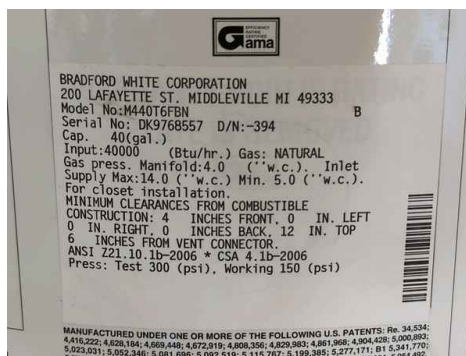
Brand: Bradford White  
 Energy type: Gas  
 Location in home: Garage  
 Capacity: 40 gallon  
 Approximate age: 17 years  
 TPR valve present: Yes  
 TPR extension present: Yes  
 Deferred cost: Yes

The typical life expectancy of all water heaters is estimated to be 10-12 years. You can potentially extend the life with yearly maintenance including servicing by a plumber, changing the anode rod(s), and draining the tank to help eliminate sediment (excluding tankless). Water heaters 10 determined to be 10 years and older are marked as deferred cost, and recommended to be budgeted for replacement.

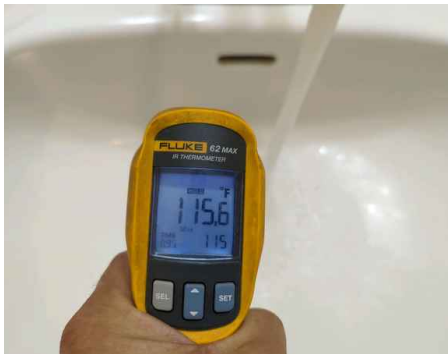
115-120

Typical hot water temperature range is between 110 and 120. Be aware that temperatures above 120 are considered a scalding hazard and the water heater should be turned down to maintain water temperatures at or below 120 Fahrenheit.

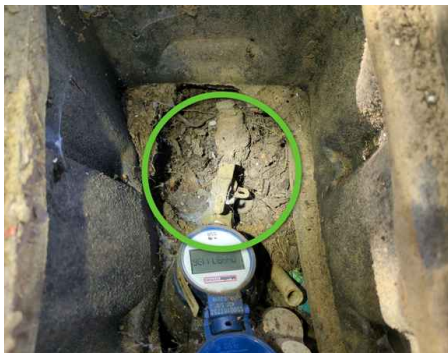
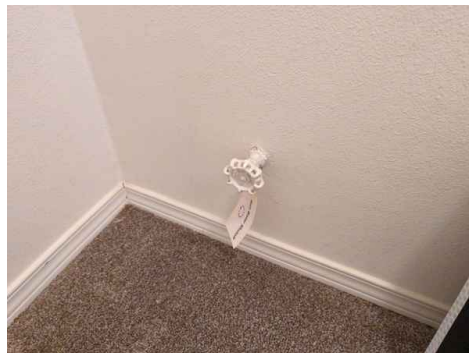
### Main Water Shut-off: Water shutoff location

Coat closet, At meter

You should note your main water shutoff location in case you need to quickly turn off the water in case of emergency. It's always good to test the shutoff to make sure it works properly before you actually need it in an emergency. It's a good idea to test it during normal business hours in case you need a plumber and be ready to shut off water at the meter if a leak develops when testing. If no shutoff is available in the home, and you have a water meter, a T handle water key is a helpful tool to turn the water off quickly. An example of a T handle water key is shown below, and is available at any home improvement store.

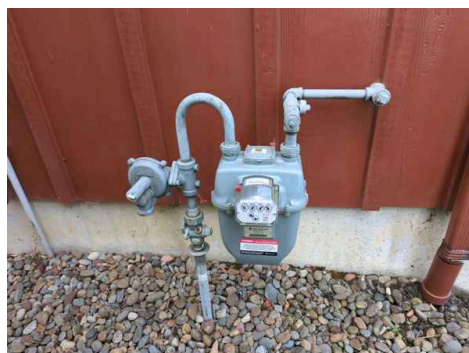
Gas shutoff at meter

The main fuel shut off is at the gas meter on the exterior of the home. Recommend knowing where the shutoff valve is located and having a wrench available to shut off gas quickly in case of an emergency.

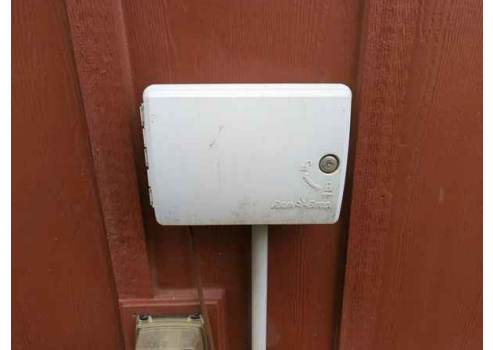
The home is equipped with an irrigation system. This system is mostly underground and not visible, is beyond the scope of the home inspection, and was not inspected. I recommend an irrigation company test your irrigation system to verify it is working properly and does not have any leaks. You may also need yearly testing of the backflow prevention device by a certified tester. The [Clark County irrigation safety document](#) is a good document for your reference.

**Additional notes:** Monitor and ensure sprinkler heads do not direct water on the home.

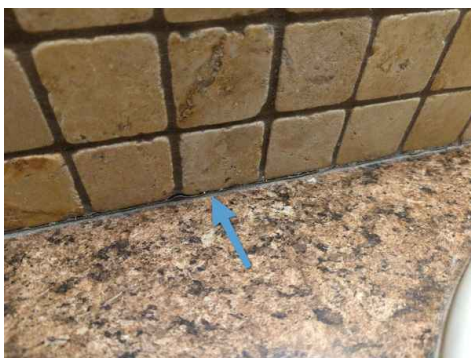
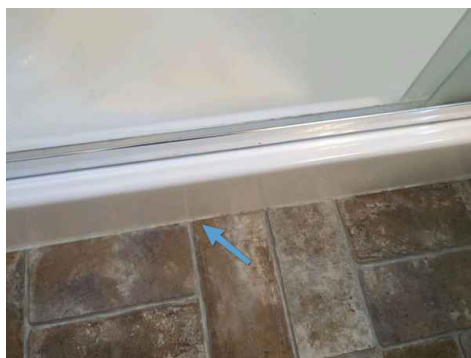
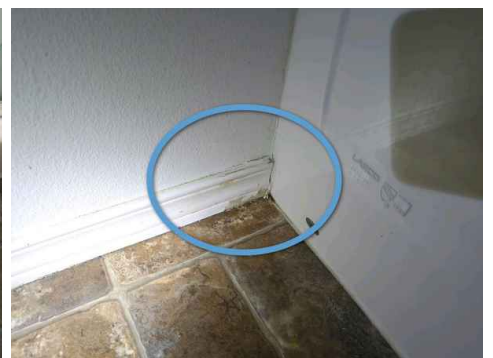
**Issue:** There is missing or failed caulk or grout in some areas where it is necessary to prevent water intrusion. Keep caulk / grout in good condition at countertops, sinks, showers, tubs, and floor areas around tubs and showers to prevent potential water entry in areas around plumbing fixtures. Some areas are in need of maintenance.

**Remedy:** Repair caulk or grout as needed.

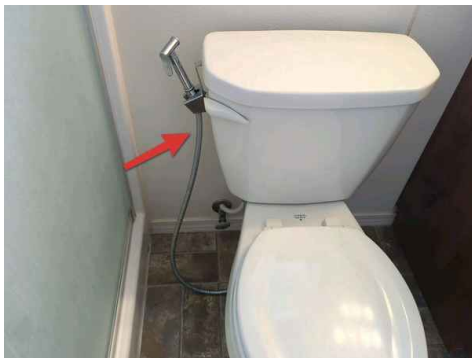
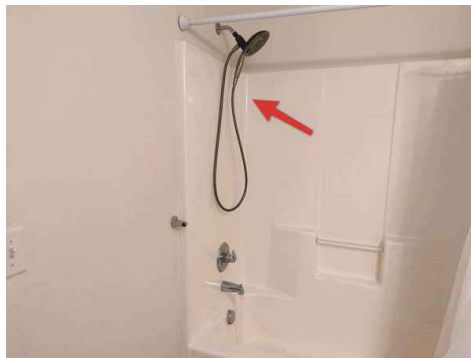
**CROSS CONTAMINATION HAZARD**

**Issue:** There is a cross contamination hazard that needs correction for safety.**Remedy:** Provide an air gap or have a backflow preventer installed.

**Additional notes and more information:** For health safety reasons, plumbing fixtures such as hose bibs, irrigation systems, dishwashers, sinks, bathtubs, bidets, etc require either backflow prevention devices or an air gap to prevent water being siphoned backwards into the home's water supply. Backflow preventers on hose bibs and irrigation systems are safety devices that prevent water flowing backwards into a home's water supply. An air gap of at least 1 inch for sink and tub faucets above the basin rim also prevents water from being able to flow backwards into the home's water supply in some circumstances.

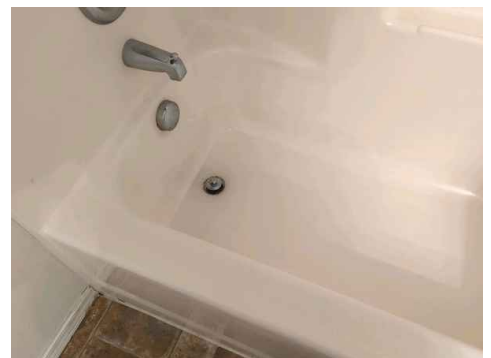
**Issue:** There is slow drainage at a sink or bathtub. Often, cleaning out the drain or trap can resolve this issue.**Remedy:** Clean out the trap or drain, and if that does not resolve the issue, contact a plumber for repair.

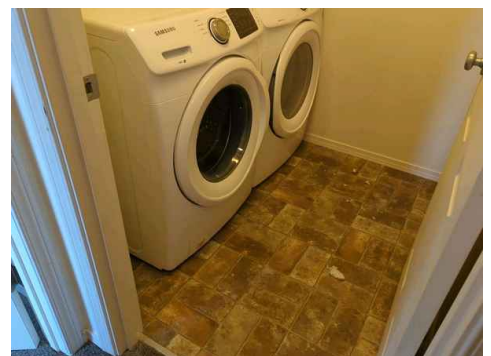
**NO PAN UNDER WASHING MACHINE****Issue:** There is no pan under the washing machine. This increases the risk of water damage if the washer leaks.**Remedy:** Have a pan installed under the machine.

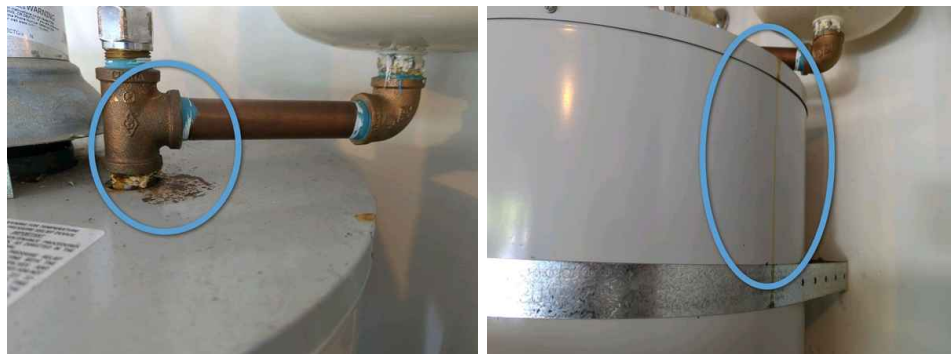
There is some corrosion around the fittings for the water heater where galvanized piping and Copper piping are connected to copper piping causing dissimilar metal corrosion. Recommend monitor and repair as necessary if leaking occurs. You can prevent corrosion by installing dielectric connectors in this location to separate the dissimilar metals.

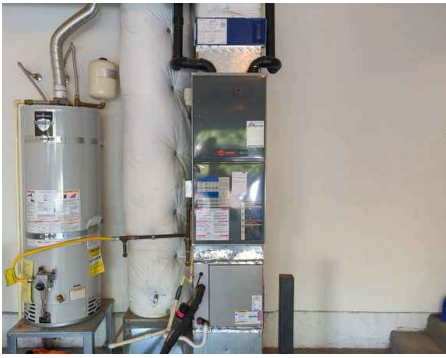
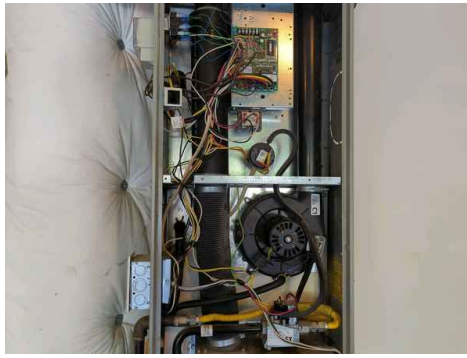
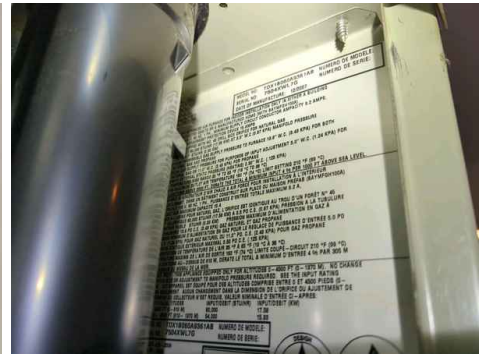
Approx. age in years: 17

This furnace unit is forced air, high efficiency, gas furnace. Typical lifespan of the average gas furnace / heat exchanger is 15 - 20 years. You can identify potential problems and extend the life of your furnace with regular servicing and inspection by an HVAC technician. Certain limitations exist for a visual inspection of the gas furnace including the heat exchanger which is not visible for inspection. We recommend having the furnace's heat exchanger evaluated when it is serviced by an HVAC technician.

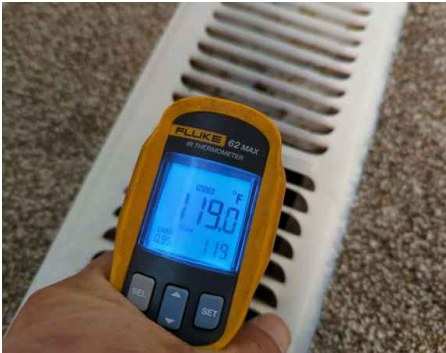
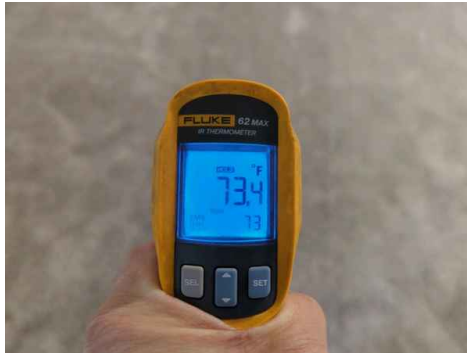
**Heating Equipment: (T) Gas furnace normal temp**

Temperature recorded: 119 F, about 46 degree temperature split

The gas furnace was operated using thermostat controls and the output temperature at the register was within normally expected temperature ranges for a furnace of this kind. Typical air temperatures at the register for gas furnaces is around 100-130 degrees at the register. Other variables will affect this temperature such as distance from the furnace, type, age and efficiency of the furnace.

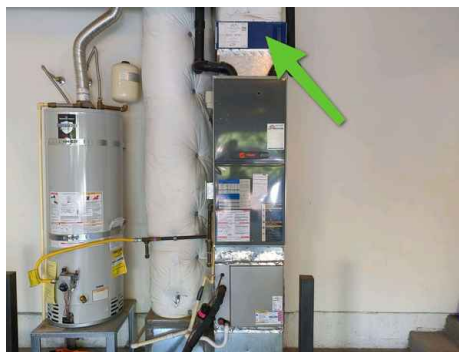
**Distribution Systems and Supporting Equipment: Filter Location**  
at the air handler, garage

**Distribution Systems and Supporting Equipment: Filter Type**  
Disposable

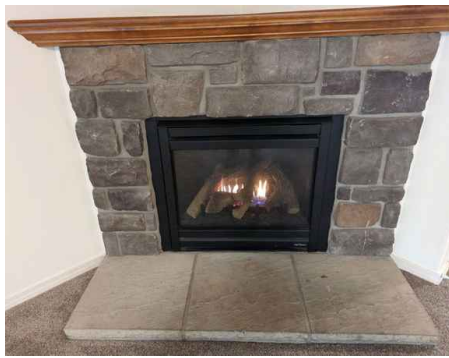
I inspected and operated the gas fireplace. I recommend inspection and servicing of the fireplace yearly to ensure it is operating safely and efficiently. I am unable to see the flue connector and piping for inspection. Be sure and clean under the fireplace yearly to remove dust and cobwebs which could interfere with ignitor operation. For your information, if you are a Northwest Natural gas customer, you can schedule a free inspection and testing of your gas

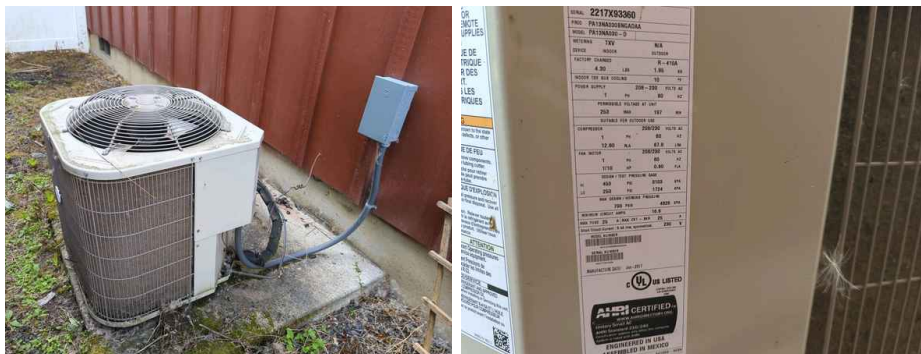
**Cooling Equipment: Air conditioner - Unit #1**

The home has an air conditioner installed. Typical life expectancy of an air conditioner compressor is 12-15 years.

I recommend yearly servicing by an HVAC technician.

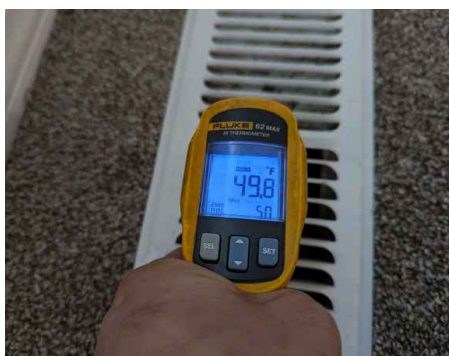
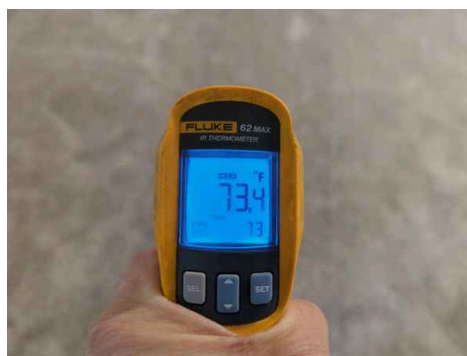
**Cooling Equipment: (T) AC cooling temp normal**

Temperature recorded: 49 F, about 24 degree temperature split

The air conditioner was operated and the temperature at the registers was within the normal expected range (14-22 degrees lower than ambient).

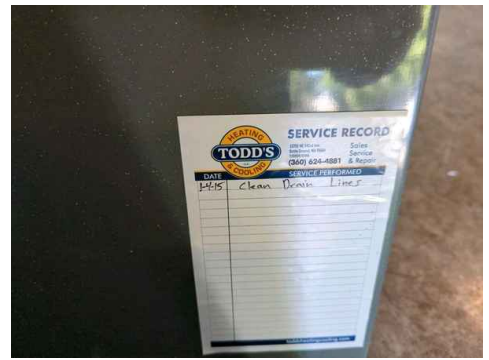
Bus service indicated 2015

**Remedy:** Servicing followed by yearly servicing by an HVAC technician. Yearly servicing helps identify issues earlier and keep the appliance operating in its peak efficiency and performance.

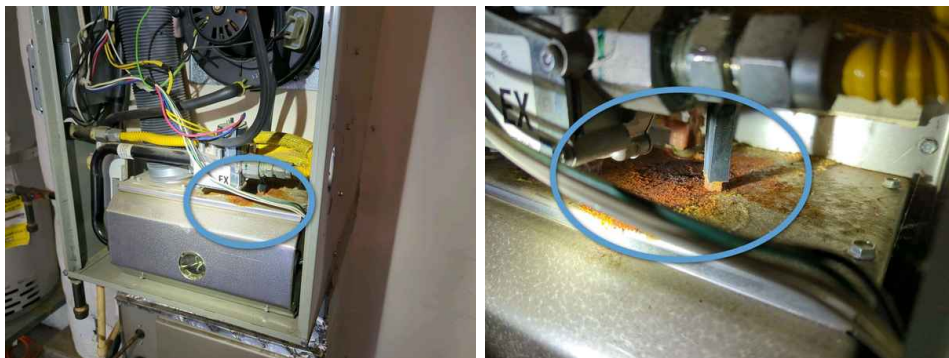
**Additional notes:** Leaking and rust in the cabinet can damage the equipment and any active leaking repaired promptly.

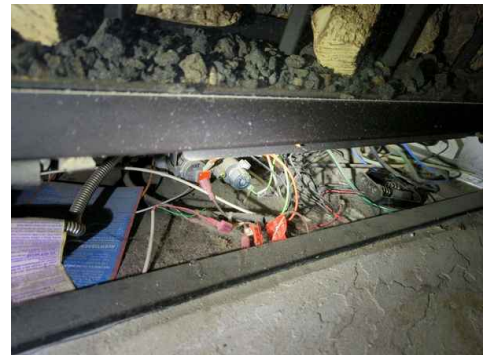
**Issue:** Maintenance needed. There is dust and cobwebs under the gas fireplace. Dust and cobwebs may affect operation of the fireplace such as making it difficult to light.

**Remedy:** Clean out dust and cobwebs now. Clean it periodically such as once per year.

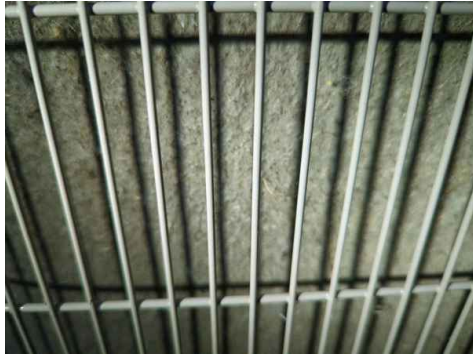
Close up of compressor fins clogged with dust and debris

**Additional notes:** Fins can be cleaned with a soft brush and vacuum. Be aware that the fins are very fragile and easily damaged.

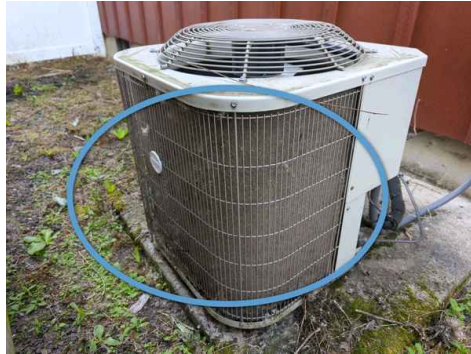
**Issue:** The compressor fins at the AC compressor are dirty and clogged with dust and debris. This will cause the air conditioner to operate at less than optimal efficiency and airflow.

Compressor fins clogged with dust and debris

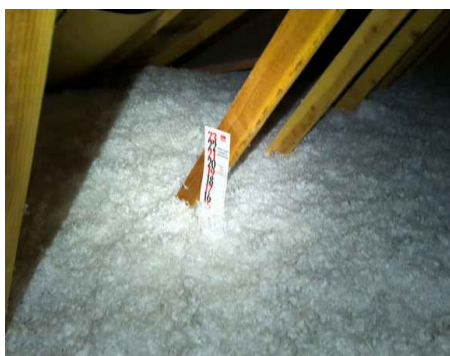
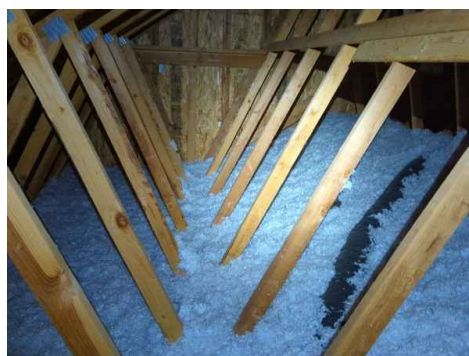
About R38 fiberglass, 13 inches

Fiberglass loose fill

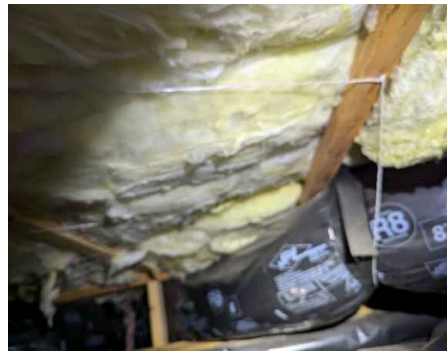
**Insulation Under Floor System:  
Floor System Insulation**

Fiberglass batts

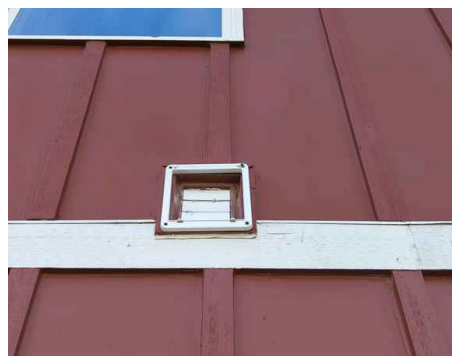
Right side

I recommend knowing the location of the dryer exhaust vent and having the vent piping cleaned periodically / yearly as needed to prevent the buildup of lint which can be a fire hazard. Have the dryer vent inspected by a duct cleaner upon move-in to determine if it needs cleaning.

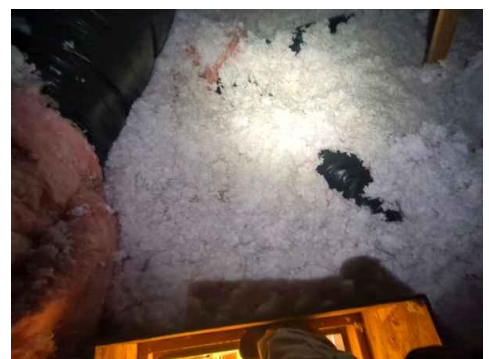
Insulation tamped down from foot traffic

**Remedy:** Redistribute or add insulation in damaged / lacking areas as necessary to bring the insulation back up to other installed levels.

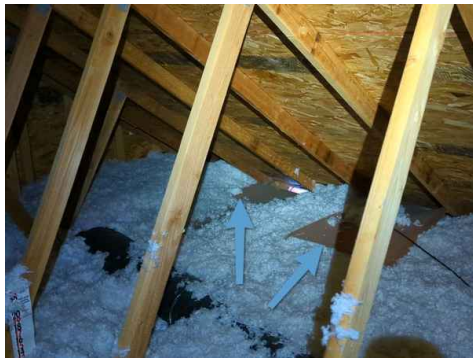
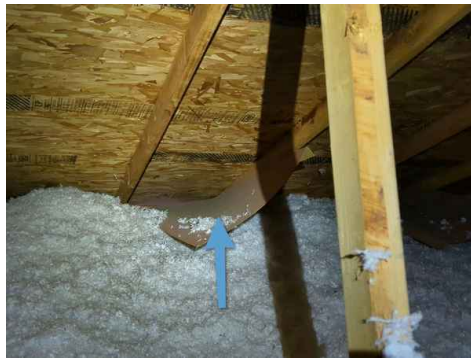
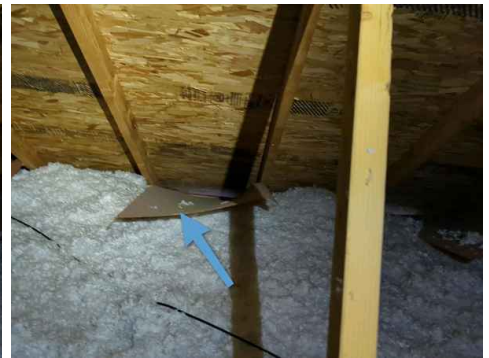
Some of the insulation baffles at the soffits have fallen down. I recommend they be re-installed to hold insulation back from blocking the soffit vents.

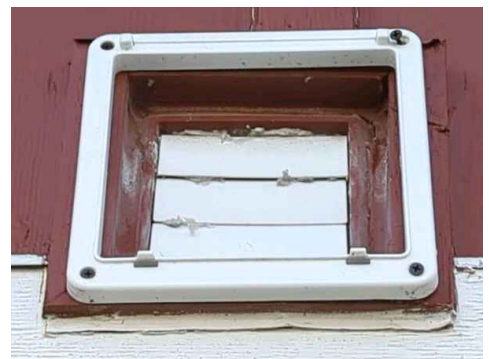
**Issue:** There is visible lint buildup in the dryer exhaust duct work. It is not always possible to see the entire length of the dryer duct, often only a small portion is visible. Lint buildup in a dryer duct is a fire hazard.

**Remedy:** Having the dryer duct cleaned by a duct cleaner.

**Recommended time frame:** Immediate

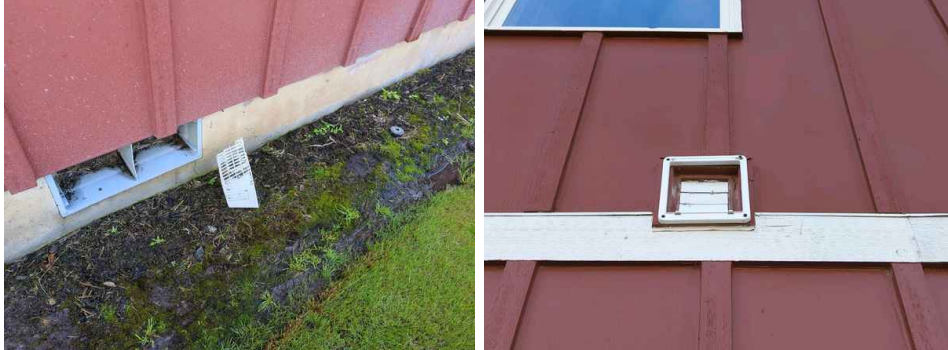
Here's the screen laying on the ground that fell off of the dryer vent termination  
Dryer vent on right side of home

**Recommended timeframe:** Immediate

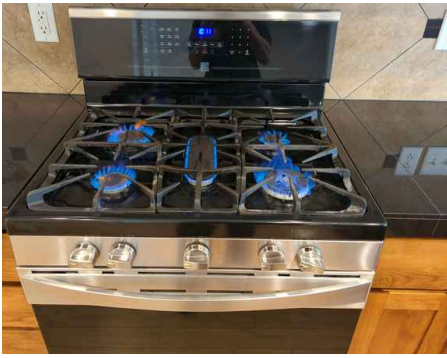
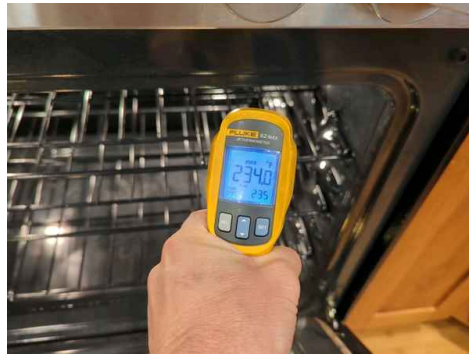
**Ranges/Ovens/Cooktops: Range / oven was operational**

The range / oven operated as expected.

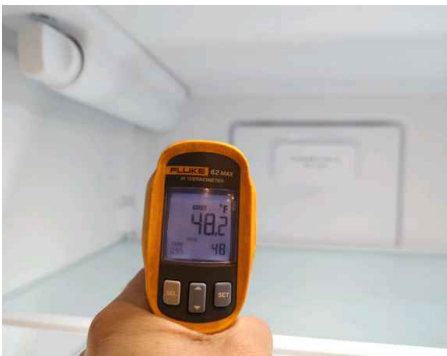
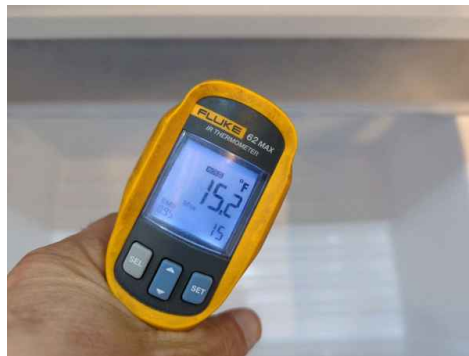
**Built in refrigerator: Non-built-in refrigerator checked as a courtesy**

Temperatures for their refrigerator and freezer were checked and found to be normal. For non-built-in appliances it is not a requirement to inspect them but this was done as a courtesy.

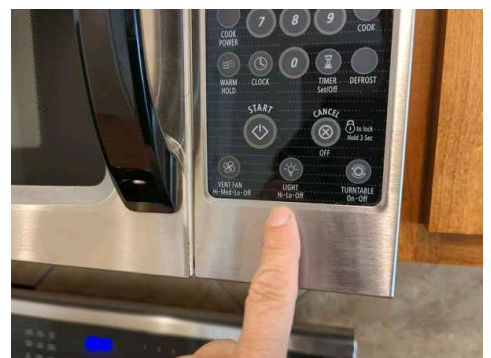
The light under the microwave is not operable and needs repair.

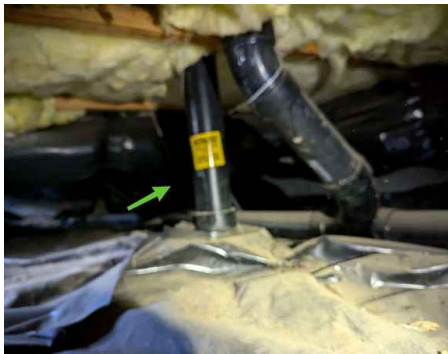
This home has Radon resistant new construction in place. There is Radon vent piping installed in the home in case it becomes necessary to make it an active Radon mitigation system in the future. This is not an active Radon mitigation system.

Radon piping in the crawl space

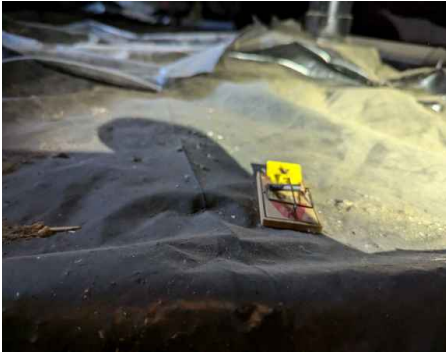
Rodent trap in crawlspace

There are some pest preventative measures installed in or around the home. I recommend consider asking the seller for more information regarding this item as I am unable to determine if pests are present. Consult with a pest control operator if necessary.

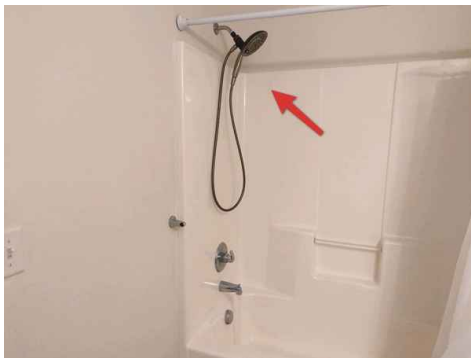
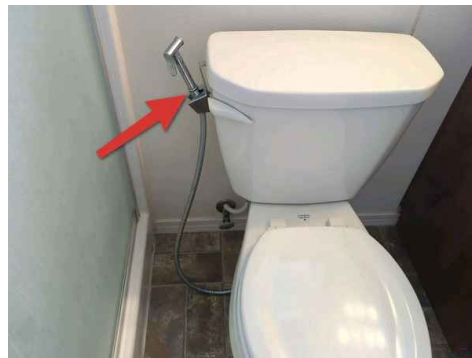
**CROSS CONTAMINATION HAZARD**

**Issue:** There is a potential cross contamination hazard. Cross contamination hazards exist when there is a potential for the building's water supply to be contaminated by things such as bacteria. Plumbing fixtures and other appliances such as dishwasher drains, clothes washer drains, and AC condensate drain lines, must have an air gap below where it drains / fills to prevent potential cross contamination of the potable water supply. There is a fixture or other item that needs correction to prevent health hazards from potential cross connection.

**Remedy:** Provide an air gap or remove the item, verify the device has a built in backflow preventer, replace device with one having a known backflow preventer.

**Notes:** some devices or fixtures may have a built in backflow preventer. Examples of that would be shower hand sprayers or bidet sprayers. It is not able to be determined just by looking at the item. You can try looking up the part or item to determine if it has a built in backflow preventer, remove the item, or replace with one having a backflow preventer.
